Application Note AN M106

Analysis of a CMOS Chip Circuit Board using the stand-alone FTIR Microscope LUMOS II

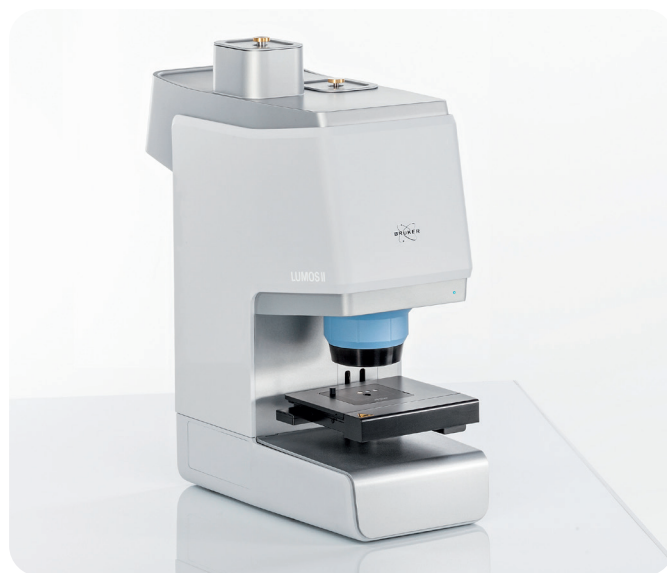
Figure 1: Stand-alone FTIR microscope LUMOS II.

complex to use and require a high level of skill. With the FTIR microscope LUMOS II (see figure 1) Bruker offers a space saving, fully automated stand-alone solution that is very easy to use.

The LUMOS II is an all in one solution with an integrated spectrometer, a high degree of motorization and a dedicated user-interface. Its 8x objective provides the measurement modes ATR, transmission and reflection and high quality visual inspection capabilities. The innovative motorized Attenuated Total Reflectance (ATR) crystal allows performing the complete measurement procedure fully automated including background and sample measurements. A high working distance and the unobstructed access for the sample stage facilitate an easy positioning of the sample. The large field of view of 1.5 x 1.2mm and the high depth of focus make sample inspection very comfortable. In combination with a motorized stage, fully automated mappings can be performed.
